Case study - Focussed resistivity

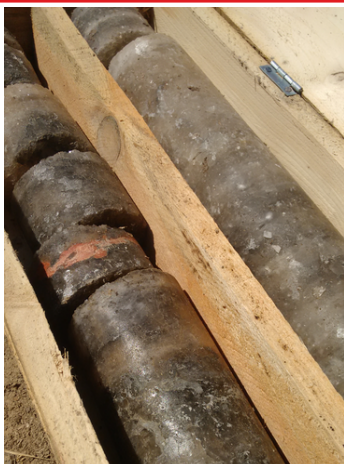
Core box photograph showing a section of the massive halite beds present in the lower part of the drilled section (left).
